INSTALLATION INSTRUCTIONS

DESCRIPTION: 2019-UP Sprinter Van 144"WB

Complete Insulation Kit

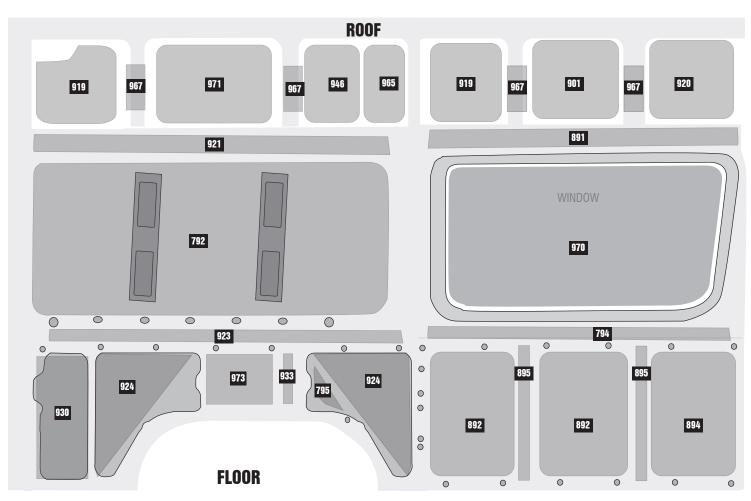
DRIVER SIDE WALL

PLACEMENT OF INSULATION

Pieces 921, 923, 891 & 794 are inserted inside structural rib

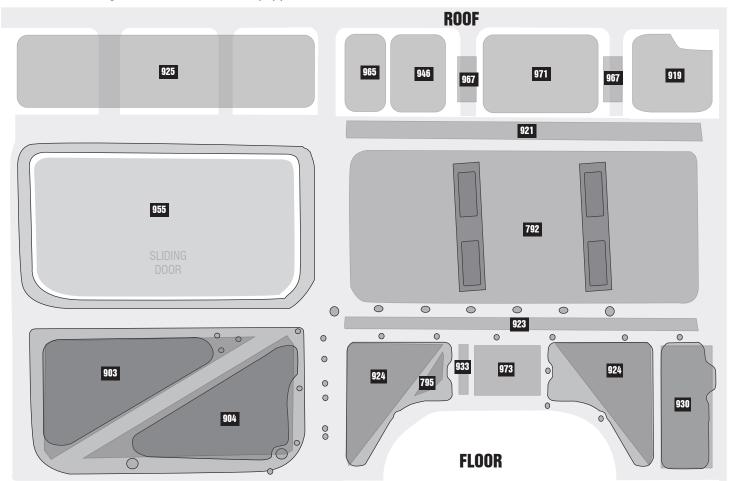
PASSENGER SIDE WALL

PLACEMENT OF INSULATION

Pieces 921 & 923 are inserted inside structural rib

Pieces 925 goes in door with door equipped vehicles

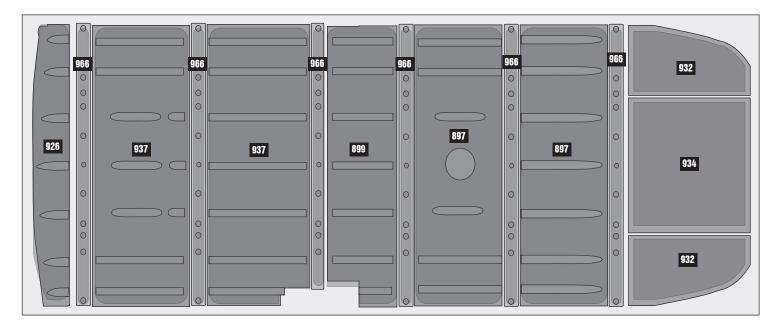
ROOFPLACEMENT OF INSULATION

Pieces 966 are inserted inside structural rib

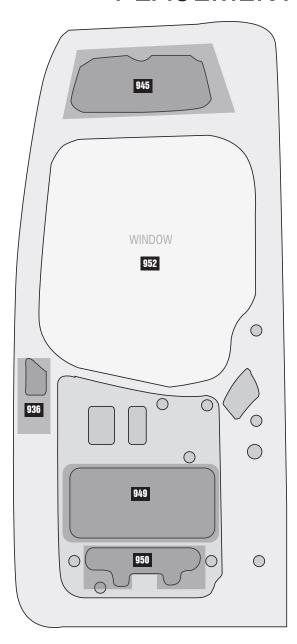
PASSENGER SIDEAS VIEWED FROM

PLACEMENT OF INSULATION

INSIDE VAN WITH DOORS CLOSED

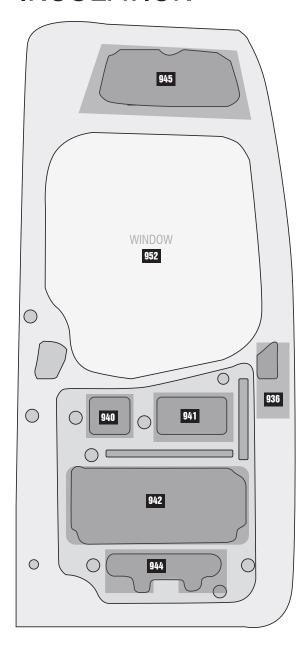
DRIVER SIDE

AS VIEWED FROM INSIDE VAN WITH DOORS CLOSED
